# Monitoring Phosphorus and Nitrogen in the Cayuga Lake Watershed, 2004-Present

*Presentation to the Water and Community Forum*

*September 28, 2019*

Stephen Penningroth, Ph.D., Director, Community Science Institute

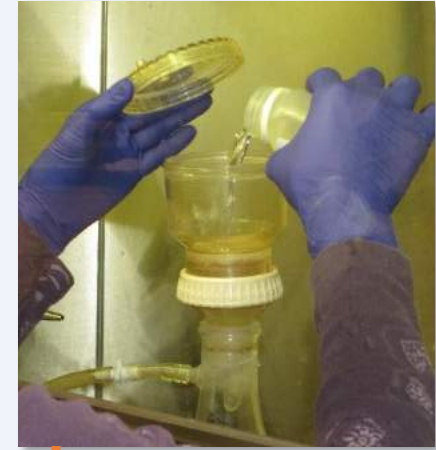
Michi tests for total coliform and E. coli bacteria

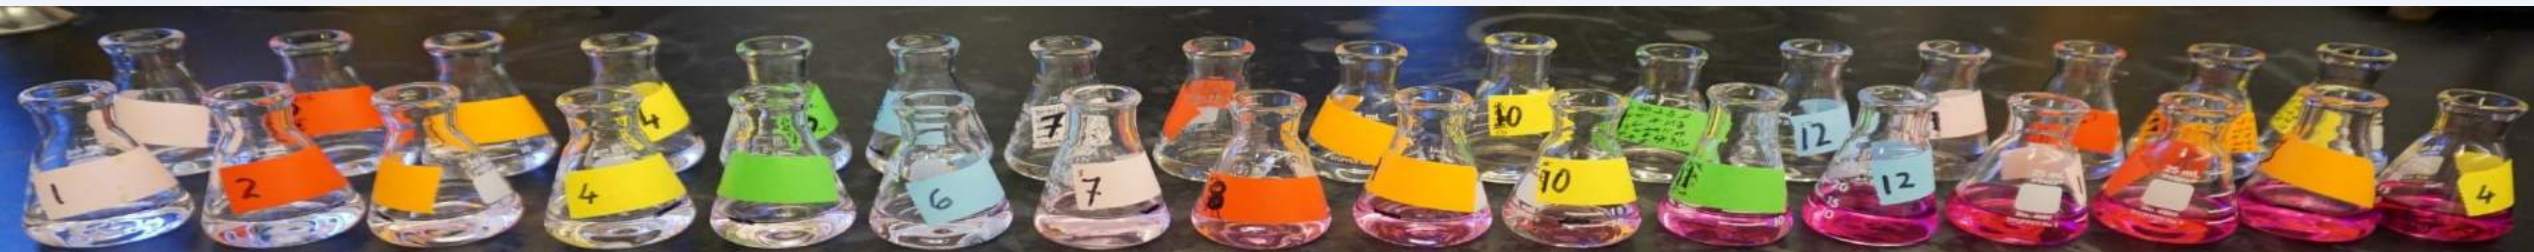
After the assay is complete  
bacteria colonies grow and  
are counted on plates

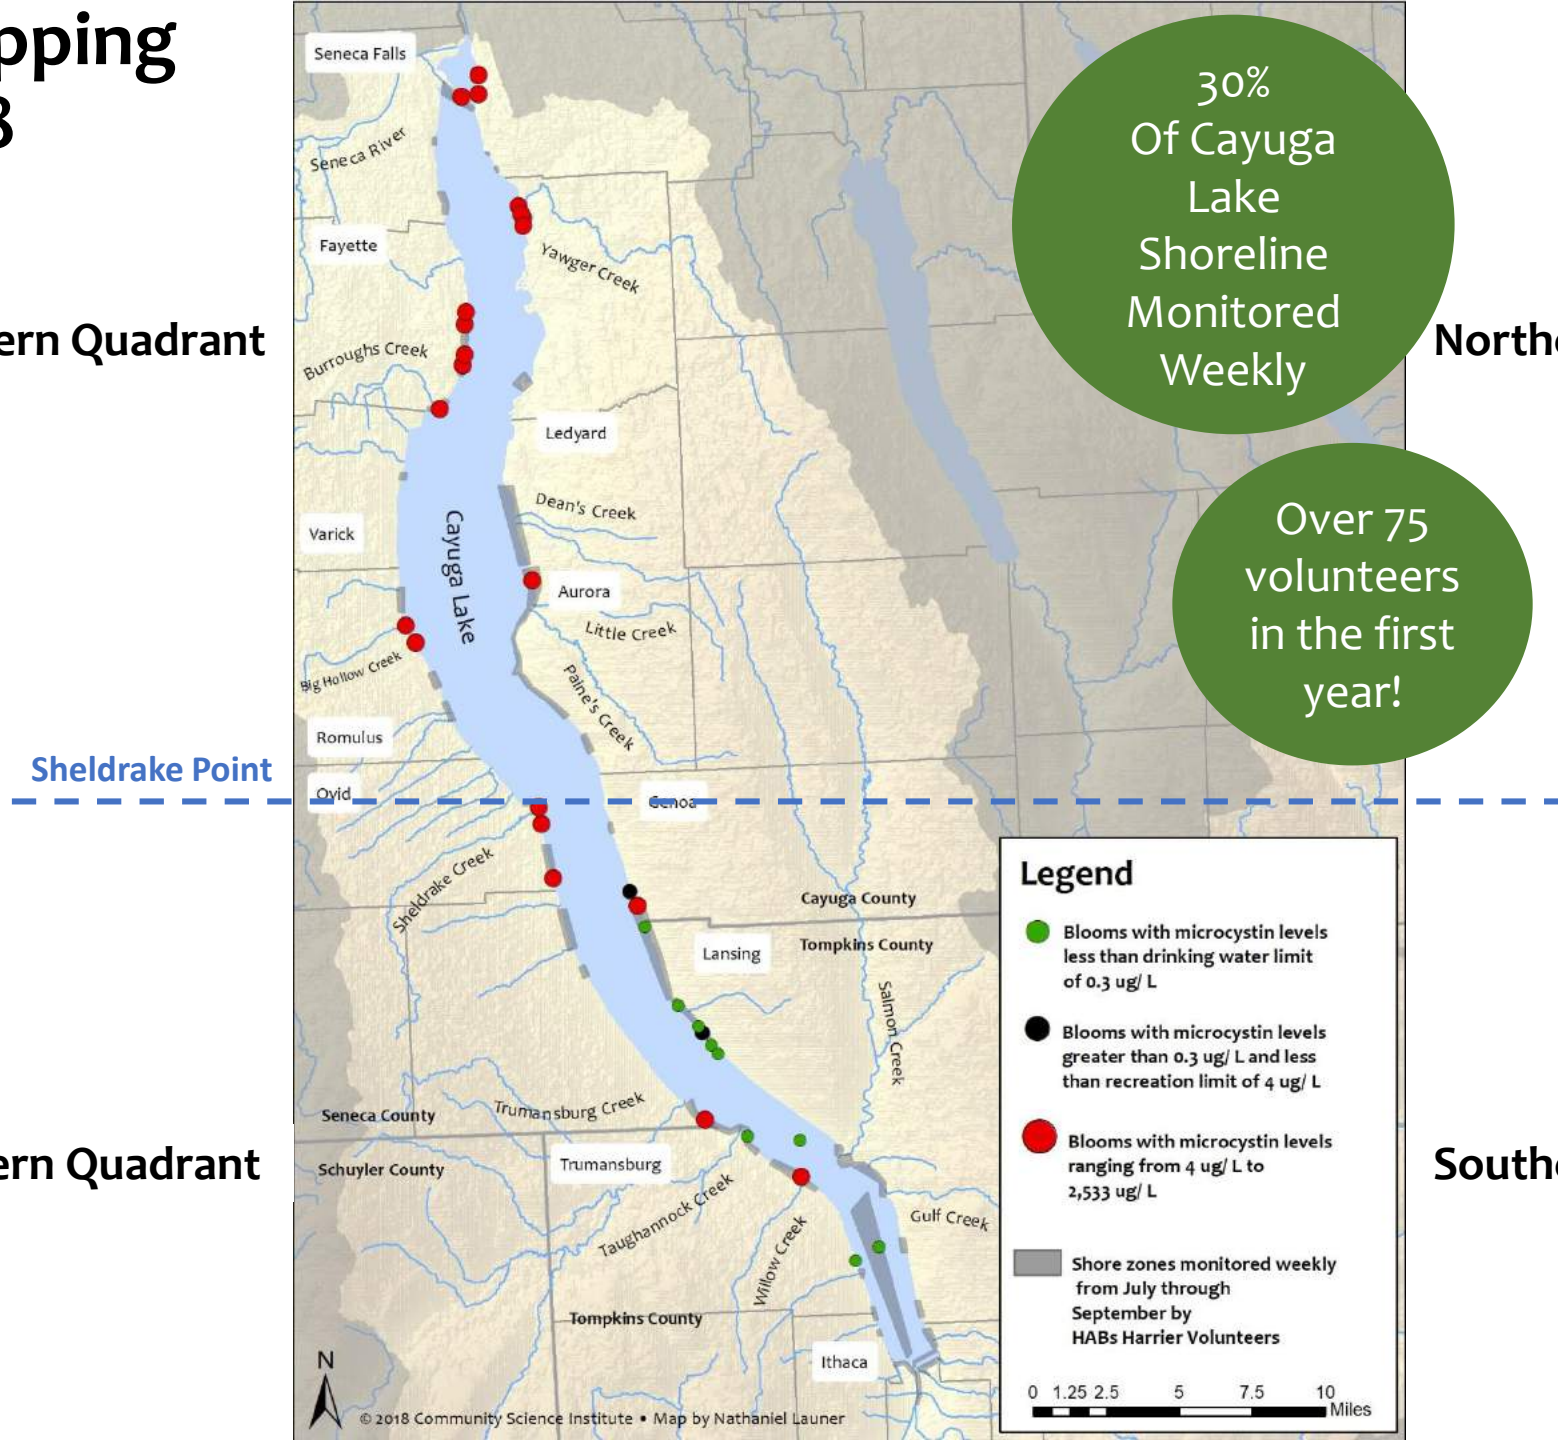
# HABs Mapping 2018
