Monitoring Harmful Algal Blooms (HABs) on Cayuga Lake in 2019

Outreach Coordinator, Cayuga Lake HABs Program Coordinator
Community Science Institute

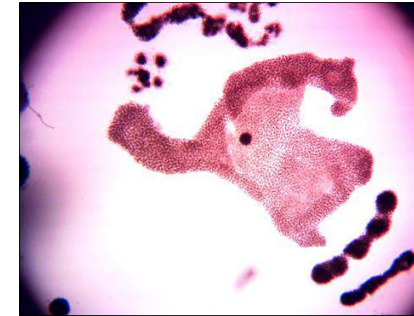
Microcystis – Produce the toxin microcystin. Have the highest population growth rates at water temperatures between X and X and have the highest rate of toxin production at a water temperature of 20° C

Blooms that occur in the northern end of Cayuga Lake in late summer have higher concentrations of microcystin and are dominated by *Microcystis*. Blooms that occur in the southern end of Cayuga Lake in early summer have low concentrations of microcystin and are dominated by *Dolichospermum*.

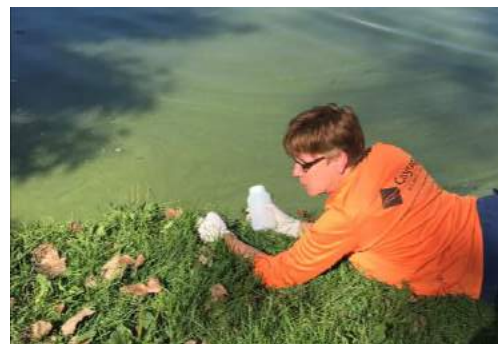
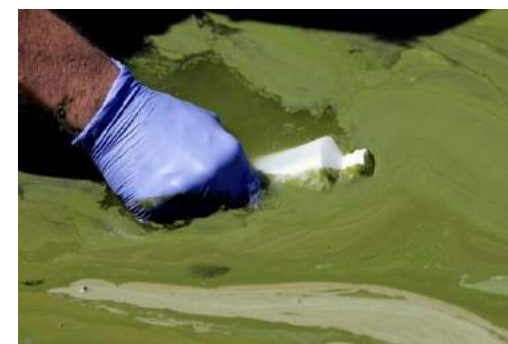
A screenshot of a web form titled "Cayuga Lake No-Bloom Report". It includes fields for "Name of Hiker(s)", "Waterbody Name", "Zone Number", and checkboxes for "I am the Zone Surveyor" and "I am the Zone Surveyor Completed". There is also a "Submit" button at the bottom.

A screenshot of a web form titled "Cayuga Lake Survey Form". It includes fields for "Name of Hiker(s)", "Waterbody Name", "Zone Number", and checkboxes for "I am the Zone Surveyor" and "I am the Zone Surveyor Completed". There is also a "Submit" button at the bottom.

- If no bloom is observed during their survey, the volunteer(s) file a No Bloom Report
- If a bloom is observed, volunteers are trained to report the bloom, collect a sample, and transport it to the CSI lab in Ithaca for analysis.
